2012-02

Brake Pedal (Valve & Treadle Assembly) Inspections

This *Inspection Bulletin* describes inspection procedures for the brake pedal (valve and treadle assembly) on air brake-equipped vehicles.

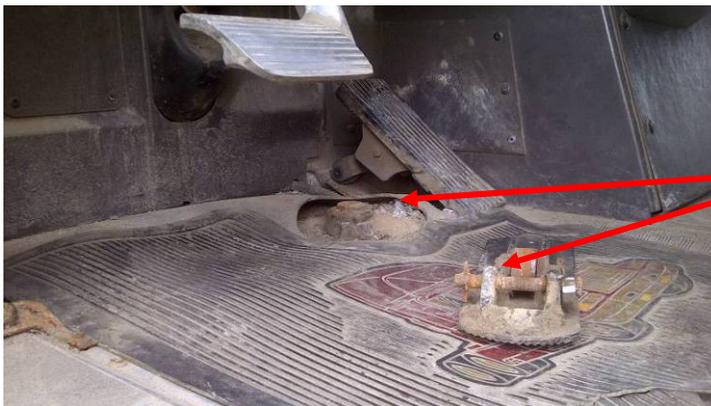
Broken Mounting Plate Ear / Pivot Support

Figure 1: A detached brake treadle illustrates a potential result of excessive corrosion damage.

In many vehicles, the brake valve and treadle (pedal) assembly is mounted to the cab floor where it is subject to abrasive dirt and sand, as well as corrosive chemicals such as road salt and water. As a result, a small amount of corrosion in the metal parts of the assembly is normal (such as light rust or oxidization). As vehicles age, the corrosion can cause pitting or reduction of component material, heavy rusting, etc., and can develop into operating or mechanical problems that can lead to brake malfunction, damage and/or failure as seen in Figure 1.

The mounting plate ears / pivot supports can become damaged from corrosion and eventually even fail. When the mounting plate ear / pivot support on one side has broken off, the treadle can operate somewhat normally. When both mounting plate ears / pivot supports break, the treadle will detach from the mounting plate and valve. These conditions can be identified with a visual inspection.

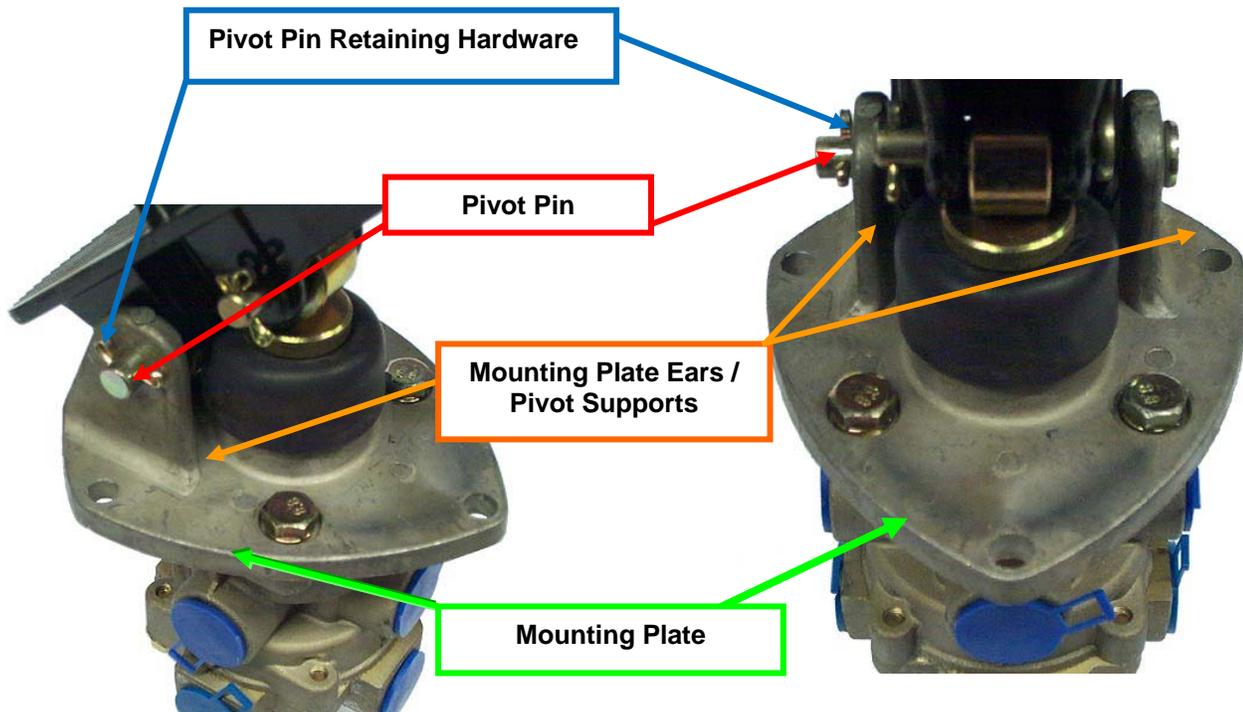
Below are images of an air brake foot valve and treadle assembly with mounting plate in new condition showing the pivot pin, mounting plate ears/ pivot supports, pin retaining hardware and mounting plate locations.
